# Rapid Impact & Needs Assessment On Caana-yaskax Flash Floods

Assessment Report | Conducted By KAALO | May 15, 2024

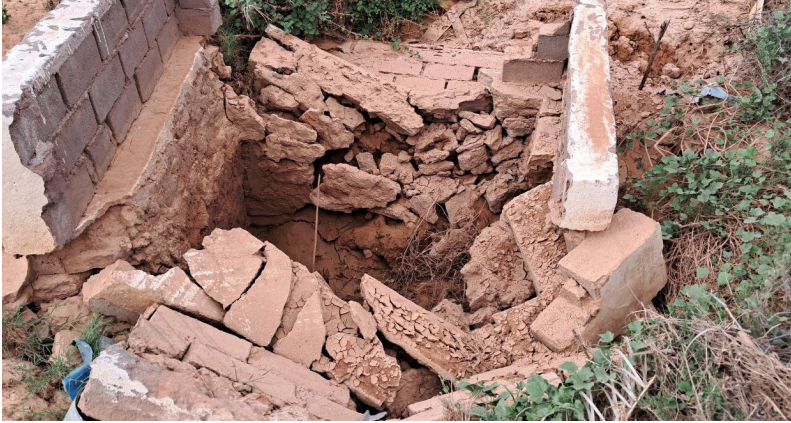
A recent flash flood in Caana-yaskax has also significantly impacted the irrigation infrastructure in the area. Field observations made by the team reveal that 20 out of 31 shallow wells used for irrigation were affected. This includes 10 shallow wells that were severely destroyed, making them inaccessible to farmers. The flood in Caana-yaskax also caused damage to the Earth dam, resulting in the removal of protective soil and rock embankments. This may increase the risk of future flooding. Additionally, the HDPE plastic sheet, silt trap & inlet canals of the dam sustained damage.

*Figure 2: Destroyed Shallow well.*

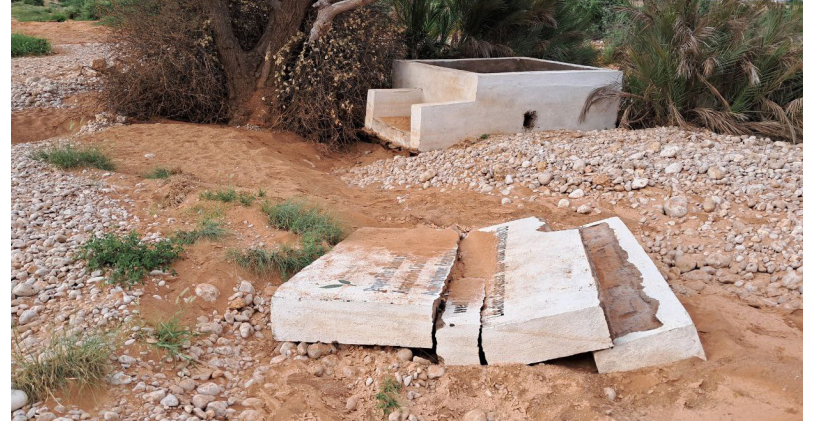
*Figure 3: Damaged Shallow well.*

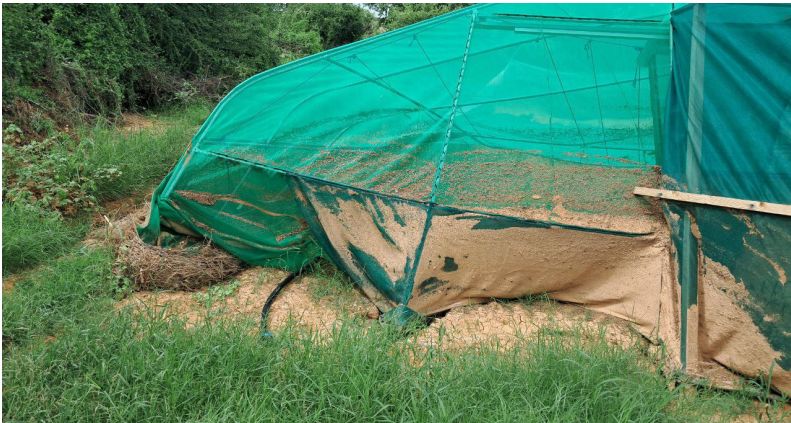
In the medium and short-height crops, all papaya trees, hot peppers, tomatoes & nearly 90% of melon crops were washed away. Furthermore, 70% of the onions cultivated in the flooded area and some lemon trees were uprooted. The average estimated financial loss to total crops being washed away is as follows: \$10,000 worth of papayas, \$15,000 worth of hot peppers & \$600 worth of onions. Furthermore, 5 out of the 7 greenhouses used for tomato cultivation were completely destroyed by the recent flash floods.

*Figure 4: Damaged greenhouse farming technology*

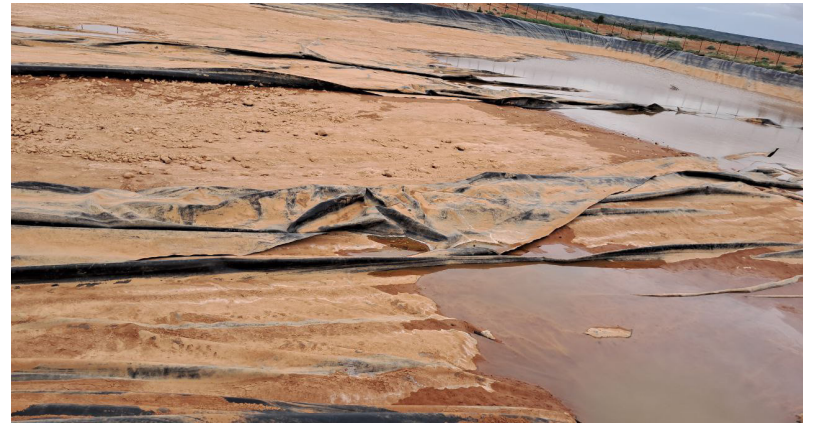
*Figure 5: Damaged HDPE sheet for the earth Dam.*

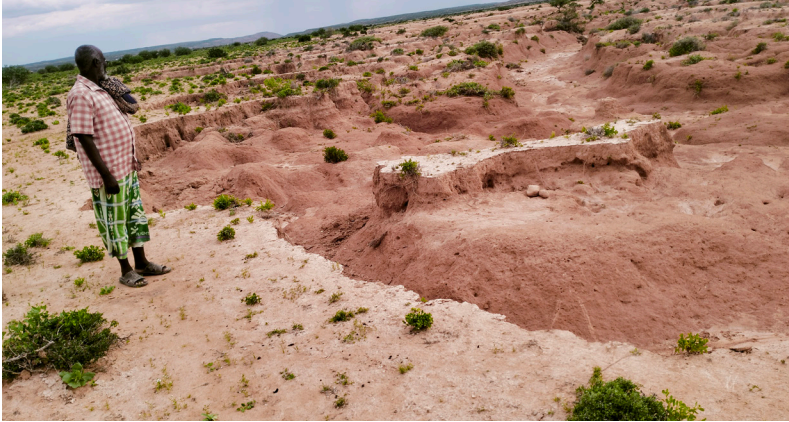
A total of 583.75 square kilometers of arable land was destroyed by the flash floods, resulting in the creation of carved channels and gullies in the landscape of Caana-yaskax and its surroundings. This phenomenon further accelerated erosion, rendering the land unsuitable for farming. Additionally, the runoff caused by the flash floods resulted in soil erosion and changes in land structure within the farming area of Caana-yaskax. The flash floods also badly damaged the existing gabion structures in Caana-yaskax. These alterations pose an increased risk of recurrence of future floods. Furthermore, the recent flash floods severely damaged gravel roads connecting Caana-yaskax to the major markets of Garowe & Gardo.

*Figure 6: Formation of gully erosion.*

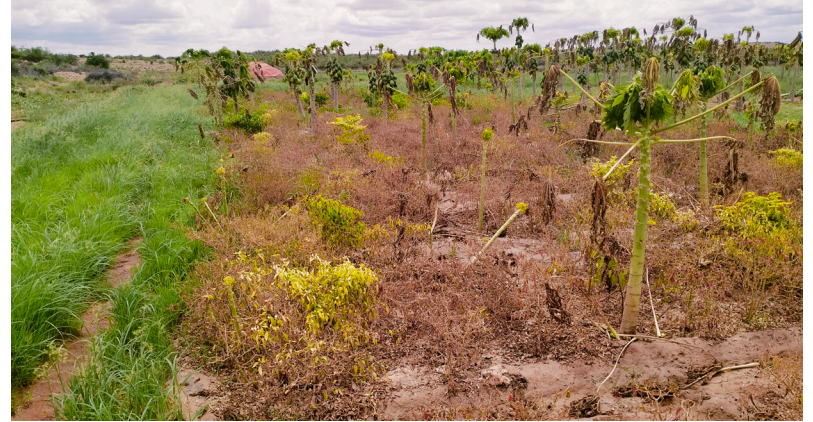
*Figure 7: Ruined papaya plantation.*

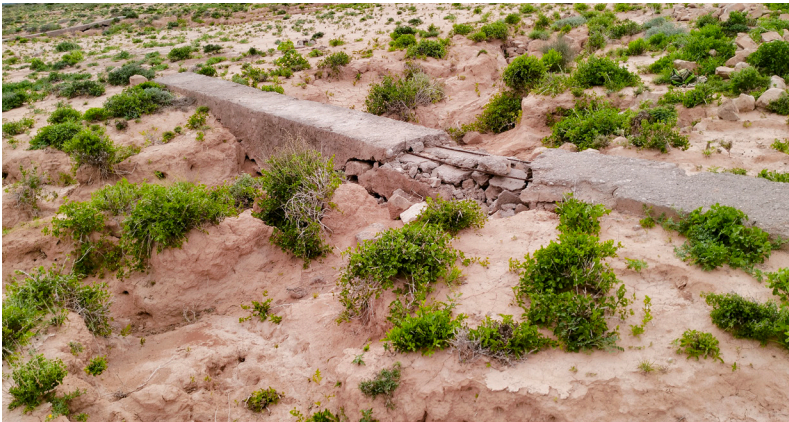
*Figure 8: Damaged check dam.*

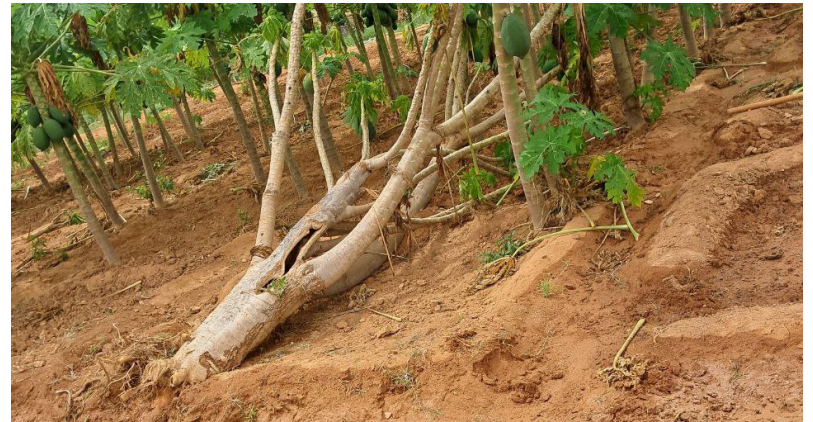
*Figure 9: Uprooted Papaya tree.*
